red eléctrica

Blackout in Spanish Peninsular Electrical System the 28th of April 2025

18/06/2025

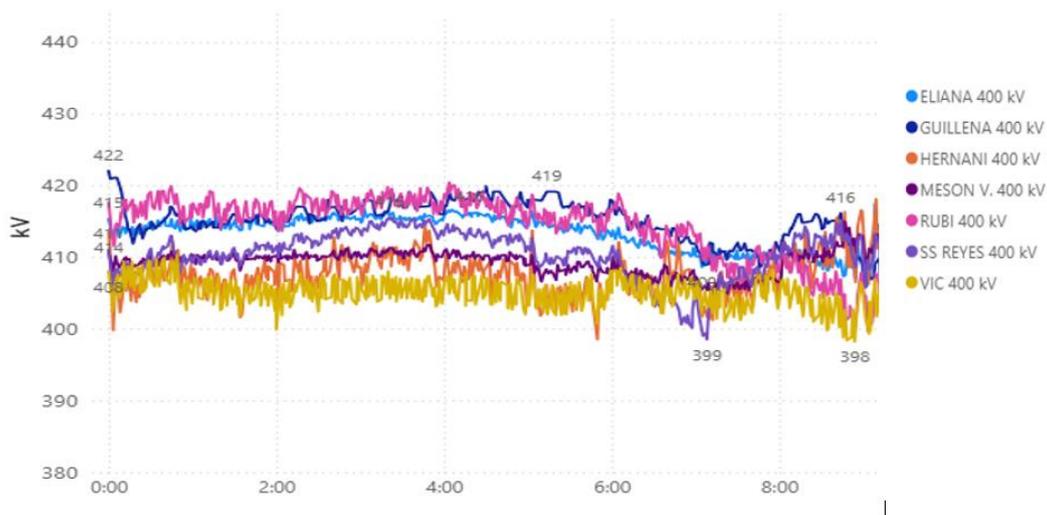
The voltage profile in the Transmission Network remained stable with minimal voltage variations until 6:00 h, coinciding with a change in the interconnection exchange with France. From that moment, voltages dropped at the same time as the demand rose until 9:00 h. During this period, two very low amplitude interarea oscillations appeared in the European system without any consequence, which is within the normal range for an electrical system with the size of the European one.

Figure 1. Voltage in 400 kV transmission network from 00:00 to 09:00 h

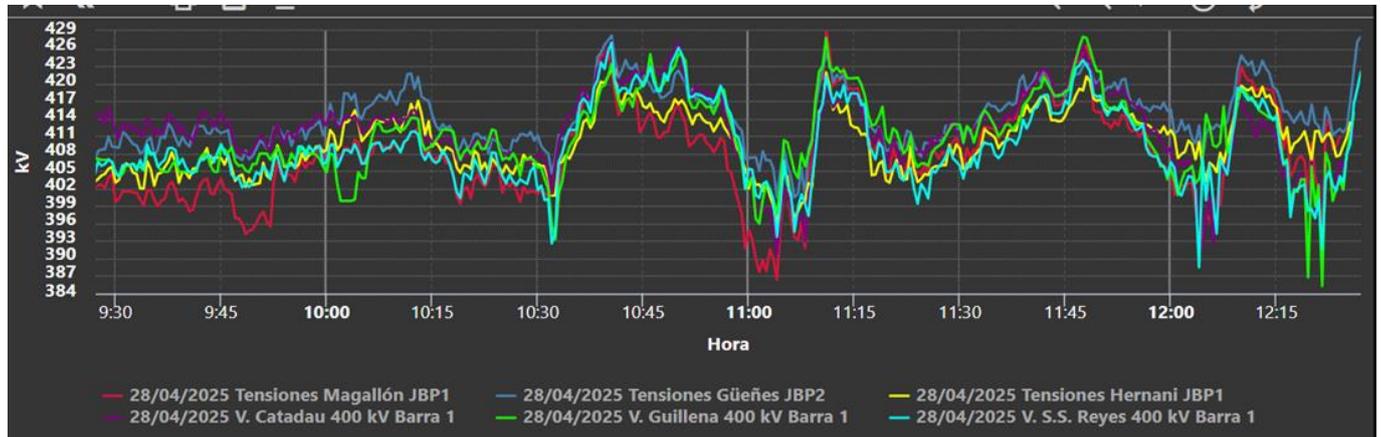
From 9:00 h to 12:00 h, a greater variability in voltages was observed, attributable to the change in the generation mix and demand variations, but without any major excursions. From 10:00 h onwards, coinciding with changes in the interconnection exchange and/or adjustments in balancing energies, voltage variations occurred in the transmission network substations, particularly around 11:00 h, when voltages dropped below 400 kV by about 10 kV.

Figure 2. Voltage in 400 kV transmission network from 09:30 to 12:30 h

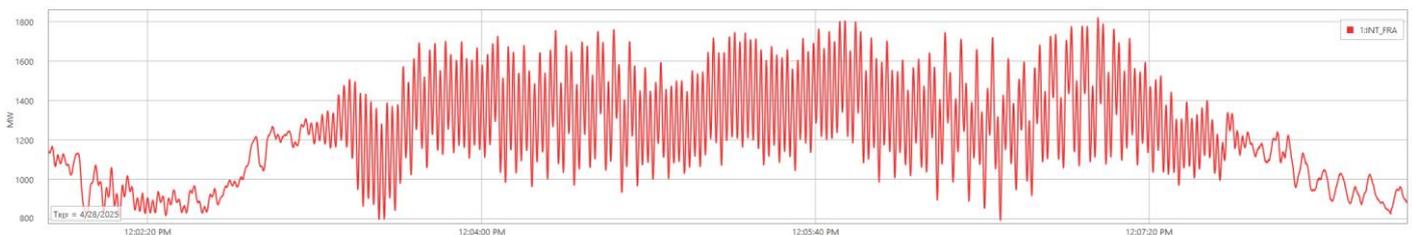
At **12:03 h, and for a duration of 4 minutes and 42 seconds, a significant 0.6 Hz oscillation** was observed in the electrical system. Coinciding with this, the damping of the 0.2 Hz frequency range dropped from 20% to 5%. Prior to the event, system voltages were close to nominal values, but the **oscillation caused a decrease in average voltage, with fluctuations reaching up to 30 kV** in the most extreme cases, ranging between 375 kV and 410 kV depending on the substation. The oscillation could be seen also in the power exchange with France.

Figure 3. Exchange Spain-France between 12:02 to 12:08 (0.6 Hz oscillation)

In response to this situation, REE Control Center **activated the pre-established measures** to improve oscillation damping and attempt to eliminate it:

- Coupling 400 kV transmission lines to reduce the system impedance.
- Reduction of export exchange with France by 800 MW until setting an export program of 1,500 MW.
- Changing the HVDC link operational mode with France to constant power mode (setpoint: 1,000 MW from Spain to France).

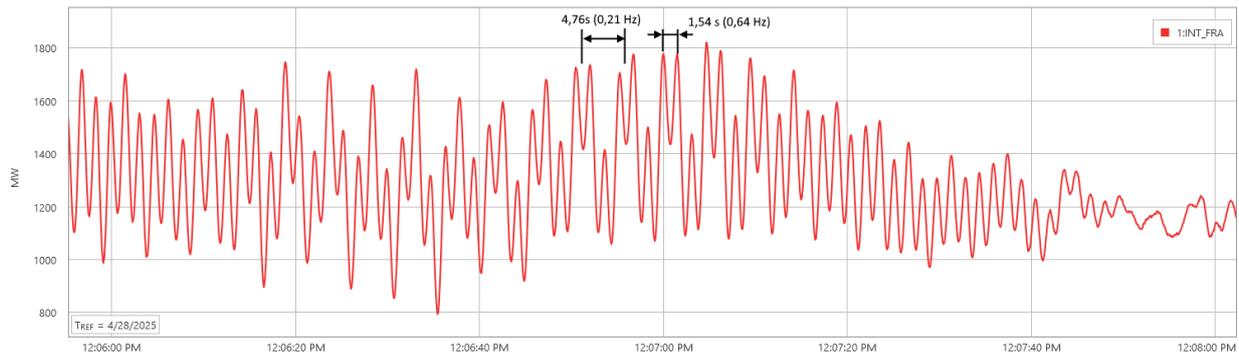
Almost at the end of this oscillation also the 0.2 Hz mode could be clearly seen coupled with the 0.6 Hz mode in the power exchange with France.

Figure 4. Exchange Spain-France between 12:06 to 12:08 (0.6 Hz oscillation)

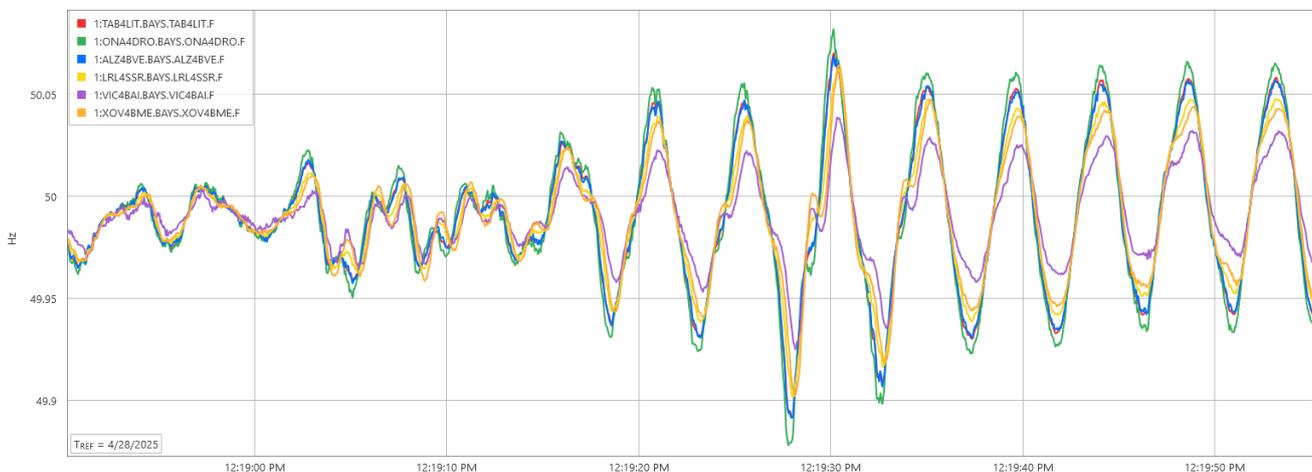
A detailed analysis revealed that the oscillation initially began at 0.6 Hz, and quickly afterwards the 0.2 Hz oscillation started. Although **PV Plant A** had increased its output from 250 MW to 350 MW at 12:15 h and no active power fluctuations were observed, variations in reactive power were indeed detected.

Figure 5. Initial moments of the 0.2 Hz oscillation where 0.6 Hz oscillation can also be observed

In response to this new oscillation, and in accordance with the protocols already activated at 12:03 h, the following measures were implemented:

- Coupling of 400 kV transmission lines to reduce system impedance.
- Reduction of export exchange with France to 1,000 MW (with the HVDC link set to 1,000 MW from Spain to France, resulting in zero net export via AC lines). This represents a total reduction of 1,300 MW.
- Reduction of export exchange with Portugal from 2,545 MW to 2,000 MW, a decrease of 545 MW.

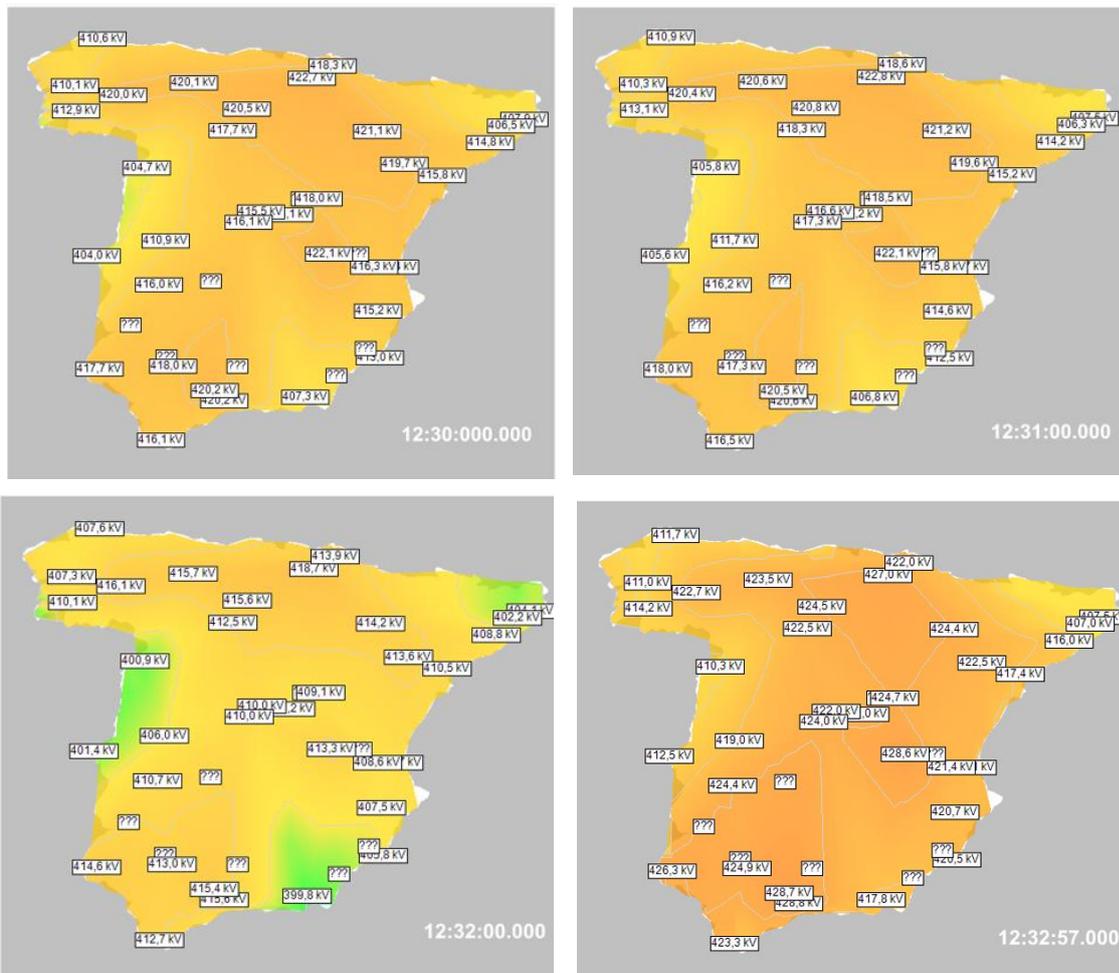
By 12:30 h, both voltage and frequency remained within the operational limits required by the System Operator (375–435 kV for 400 kV systems and 200–245 kV for 220 kV systems). However, a continued upward trend in voltage levels was observed.

Figure 6. Phase-to-phase voltage in the Spanish 400 kV network

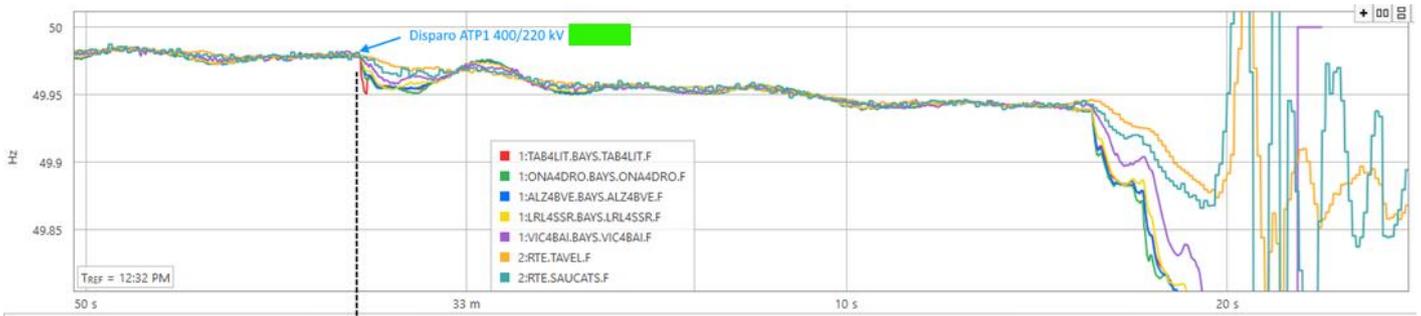
At 12:32:57 PM, a trip occurred at a **substation located in the province of Granada** involving the 220 kV side of 400/220 kV generation transformer, which at the time was supplying 355 MW to the transmission grid and absorbing 165 Mvar. The voltage at that transmission substation was below 418 kV, within the acceptable range. This is evidenced by the fact that, following the trip, voltages increased to 424 kV.

Figure 7. Evolution of the system before and after the trip in Granada

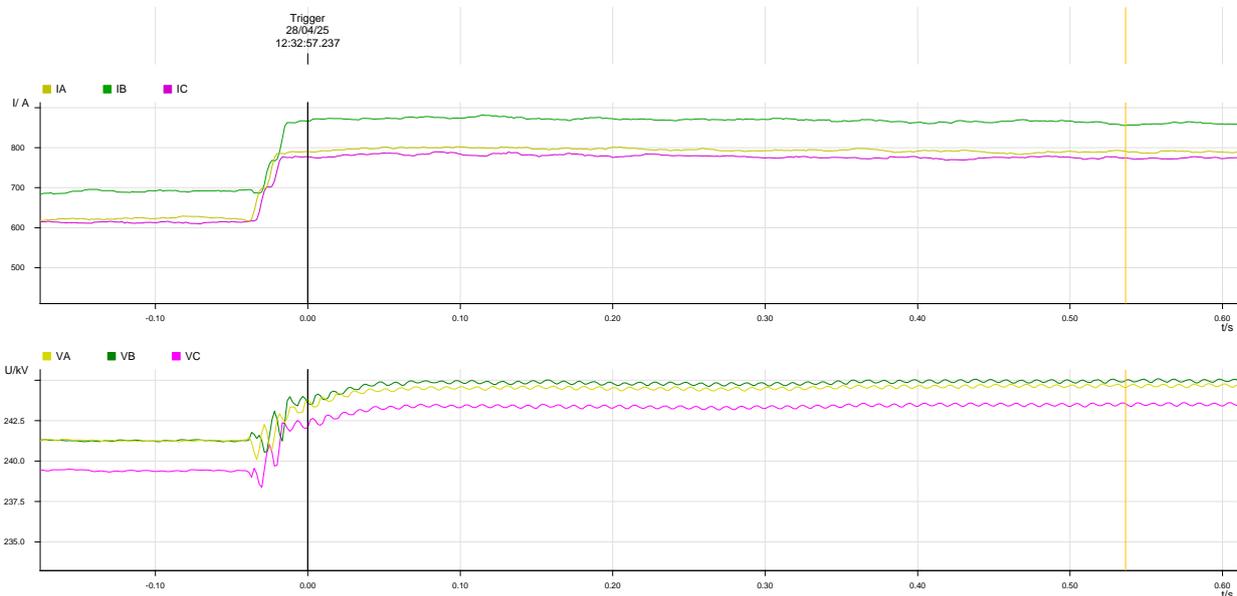
Figure 8. Line protection relay oscillography recorded simultaneously with the transformer trip⁵

Since there were no overvoltages on the transmission network 400 kV side—and the values were well below such thresholds—it could, once again, be inferred that the cause lies in the generator transformer tap setting. As the system was recovering from previously low voltages, the transformer was likely operating with a tap position configured to maintain appropriate voltage levels at the 220 kV collector substation and the associated evacuation network. As voltages began to rise, the tap changers may not have responded quickly enough, potentially resulting in overvoltages on the secondary side without corresponding high voltages on the primary side of the transformer.

The disconnection of this installation is not correct, as the voltage in the point of connection with the transmission system remains within the limits established in grid codes.
